The conservation and restoration of architectural surfaces as a learning process

Abstract: In order to bridge the gap between theoretical, technical and practical attitudes towards Brazilian field of conservation of historic buildings, and to bring together necessary information to decision making process for the conservation of architectural surfaces of a 19th century Historic House Museum, a research project, involving different professionals from scientists, researchers and also workers, has been developed since 2011. This paper deals with the achievements of the research project Preventive Conservation Plan of Casa de Rui Barbosa Museum: Conservation of Architectural Surfaces emphasizing three aspects of the process that have been also been a training and didactic experience, both for researchers and for other professionals involved, as this kind of investigation is very unusual in the field of cultural heritage preservation in Brazil.

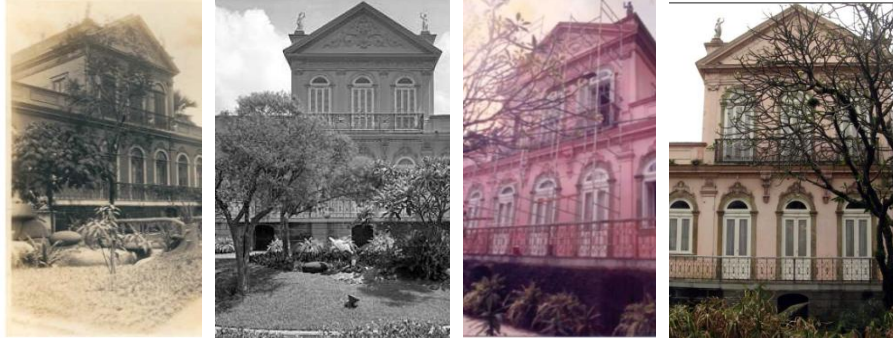
Figure 1: House of Rui Barbosa 1930, 1970, 1980, 2013. FCRB files

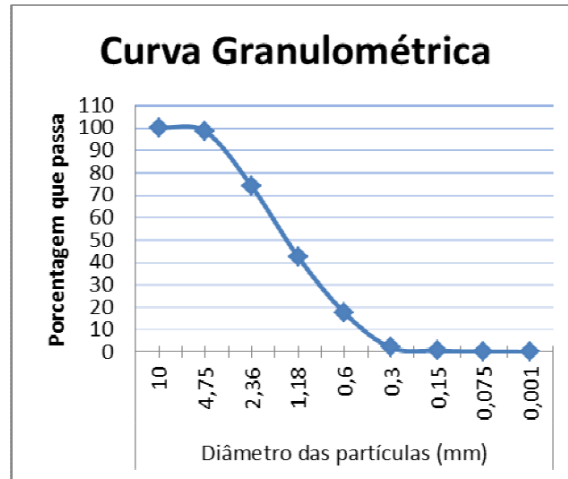
The first parameter defined was the type of sand to be used. The sands influence the behavior of mortar according to their particle size, and especially of their origin. We used a known source of sand, and washed free from impurities (clay, twigs, etc.). To ensure good cohesion between aggregate and binder was made to grading curve of the sand to ensure a balance in its composition.

Figure 2: Grading curve of sand used in the test mortars. FCRB files

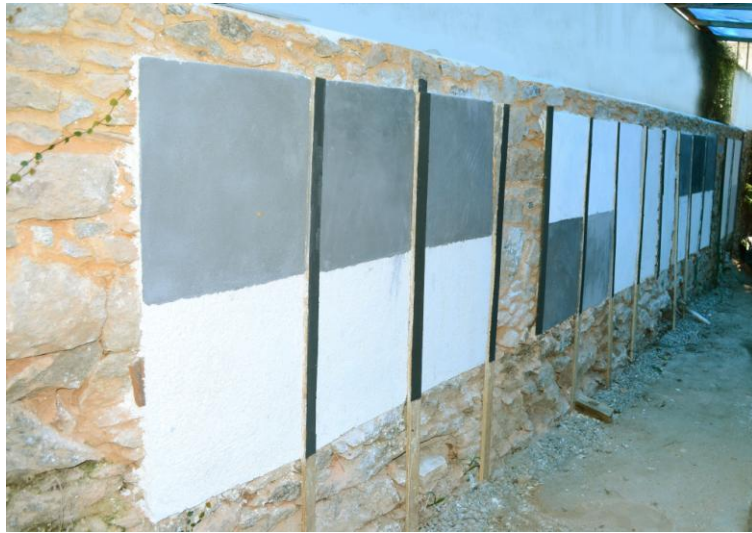
Figure 3: Overview wall test. FCRB Archive by Claudia Carvalho

After application of the test-mortar the panels were monitored for 6 months, and ended this period samples were taken for laboratory testing. Planning for monitoring the behavior of test-mortar followed the manual of recommendations for visual monitoring with the use of techniques and materials for easy access. Started in the preparation of the mortars, and duration for one year after the application, the analysis refers to workability, water content, time of healing, the reduction in carbonation, the hardness (abrasion resistance), the cohesion, the variation in color and texture.

Mortar test group B showed significant change in the plaster coating. Retractions gave rise to cracks visible to the distance (cited in the application cracks were observed), probably caused by the amount of water in the formulation of mortars and lowered rest time. Among the plaster mortars this group, the one with a more satisfactory behavior was the mortar test group B, 3, to present more sand ratio (trace 1: 5), which reduced shrinkage and consequently the number of cracks It was lower. The hardness and cohesion test mortars this group showed a very satisfactory result, and the mortar were very homogeneous, as a function of lime has been slaked with sand. Regarding the finish, the plaster appeared more homogeneous with respect to color and least for texture; and painting presented somewhat homogeneous results regarding color and texture. The lack of practice in the formulation of this type of lime mortar raises questions about its use on a large scale.

The group C mortar test showed good results with regard to the plastering with regard to cohesion, hardness and shrinkage. Already the finishes did not have the same performance. The plaster had a homogeneous texture but there was a slight variation of colors. In the paintings the results were well below both in colors that varied greatly, as in texture, very irregular.

The Group D-mortar test showed very different results in relation to the other. The smoother texture, very similar to a cement mortar, more gray color, highly cohesive materials and much lower hardness. The paint employed in this mortar, the base potassium silicate show uniformity with respect to color and texture, but its finish, slightly glossy, can compromise the outcome when used over large areas.

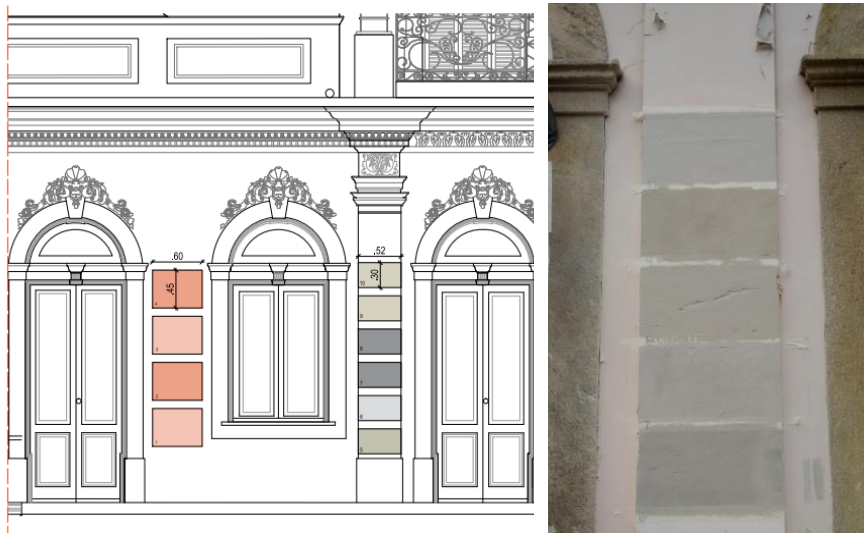
A field experience has been done, and the results are being analyzed in the time of this article is being written.

Figure 4: Wall Paintings testing
